# Hydro-power Engineers

## Case Study:

Site: New Mills, Derbyshire  
Turbine: Archimedes screw  
Power: 63kW  
Head: 3.0m

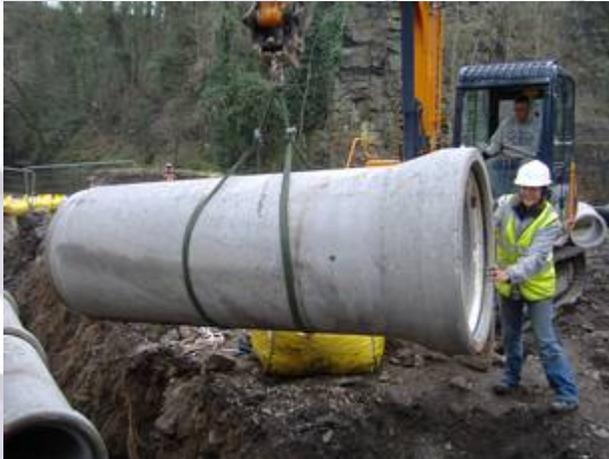
Work physically started in March, replacing the storm water discharge, which had to run through the intake area

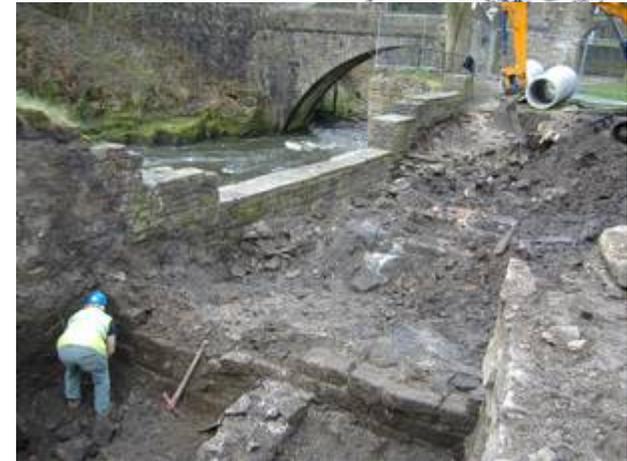
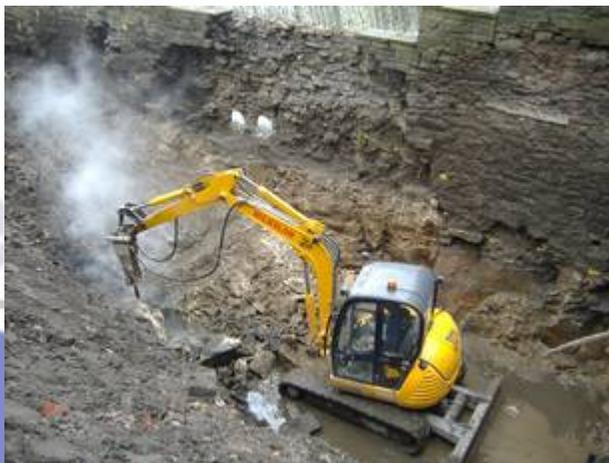
After the diversion was complete, archaeological excavation by WRE, under the direction of staff from Archaeological Research Services continued for a month. The extensive remains on site were documented and artefacts retained, as part of the planning permission

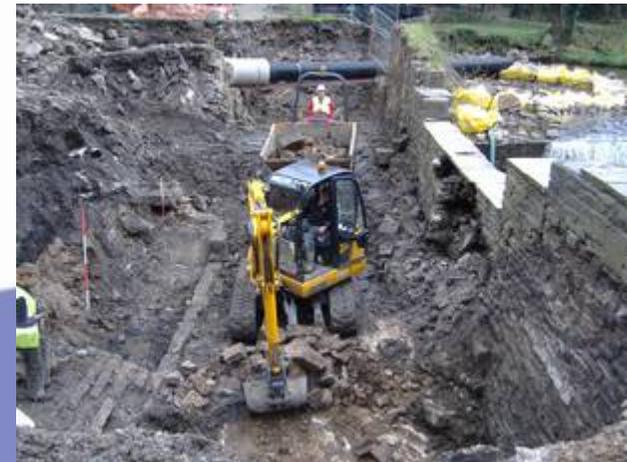
Once through the level of archaeology, another 3m of Gritstone bedrock was removed to provide the correct tailrace depth

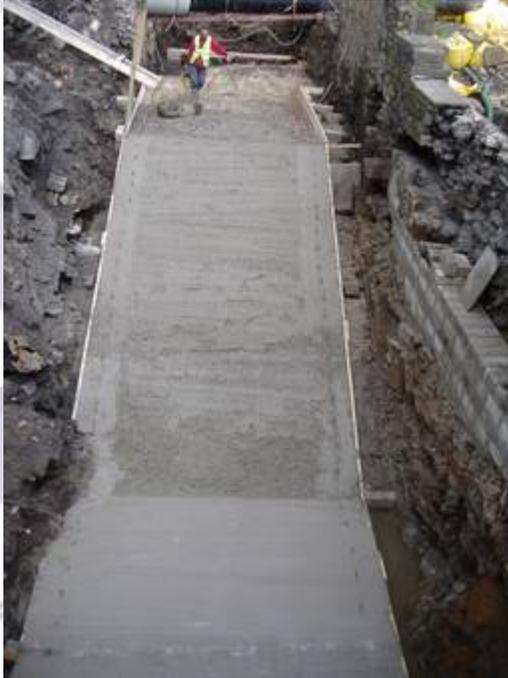
The floor pour for the turbine and fish pass then occurred

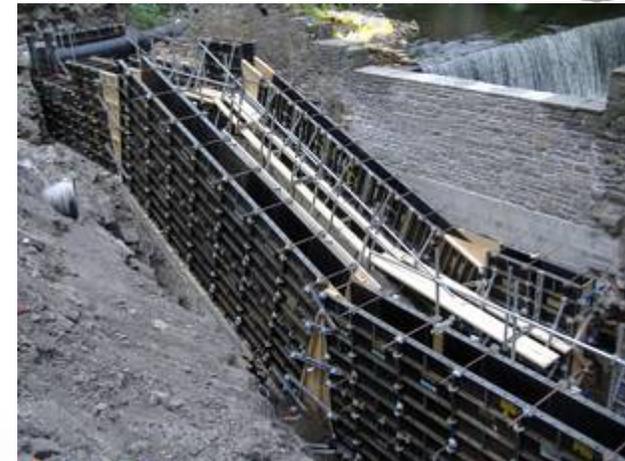
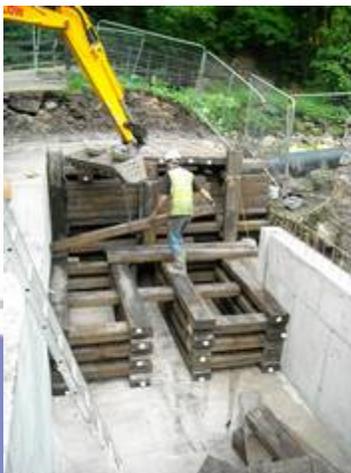
The restricted access to site required all the walls to be cast in one day, when the pump, pipelines and manpower was available, and access could be arranged for the procession of concrete lorries, so all shuttering for the structure was set up to be carried out in one pour

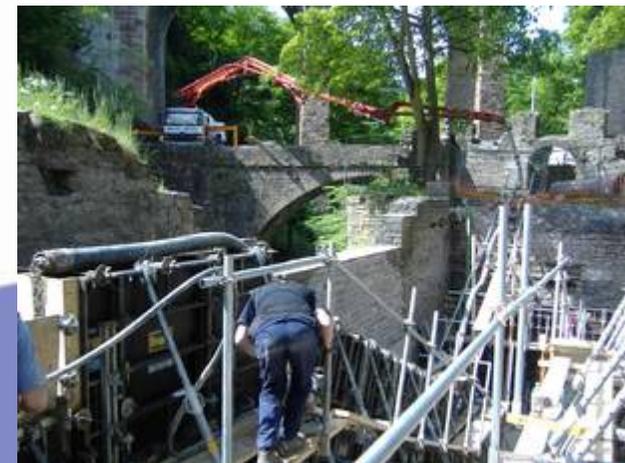
With concrete complete, the complicated phase, unique to the Torrs project was started. Because weight on site was limited to 7.5t, no crane could be brought it, and indeed the turbine itself exceeded this weight. Firstly wooden ramps were installed

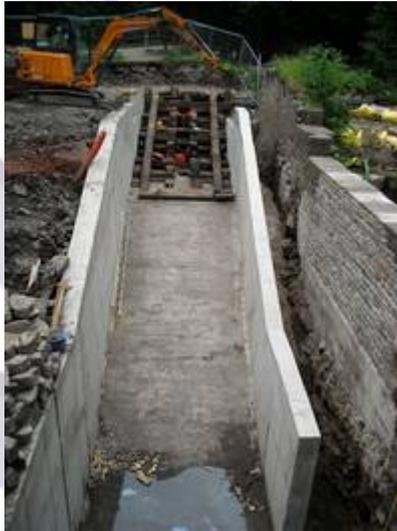
The wooden ramp provided a continuous slope from ground level to the bottom of the slope. Because of tight space restrictions, the screw had to be brought in sideways and lowered onto the ramp

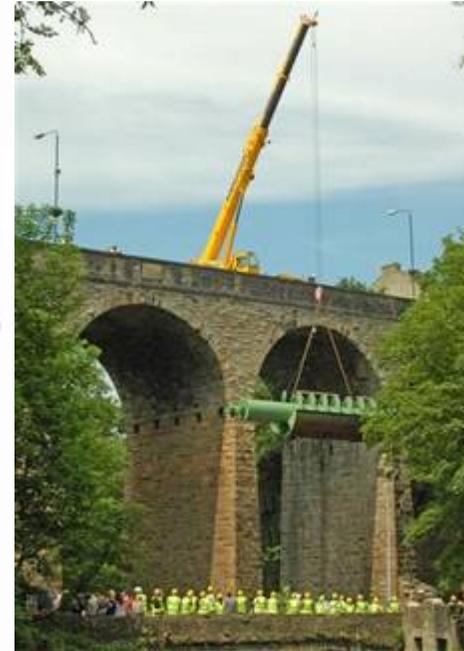
With the main road through New Mills closed, and hundreds looking on, the screw was lowered into the gorge, to avoid the weight restrictions on the normal access route.

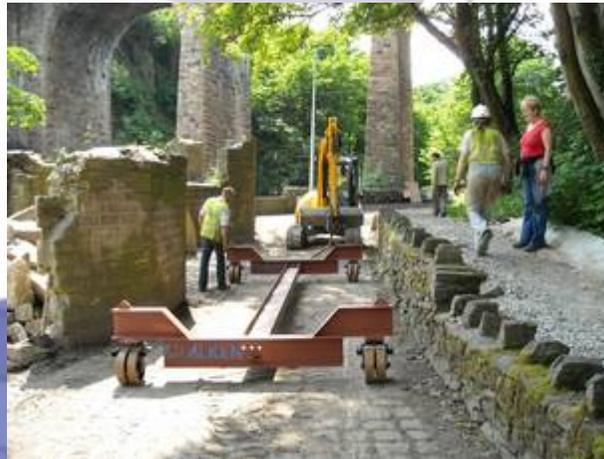
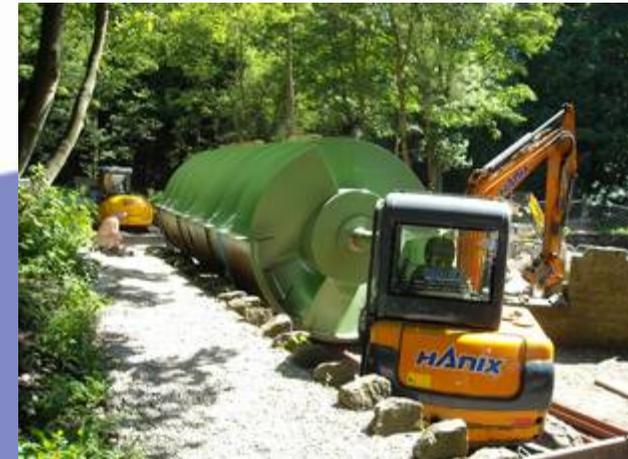
The turbine landed on a purpose built trolley, with steerable castors, which was rigidly coupled to two mini diggers to pull it into position at the top of the ramp

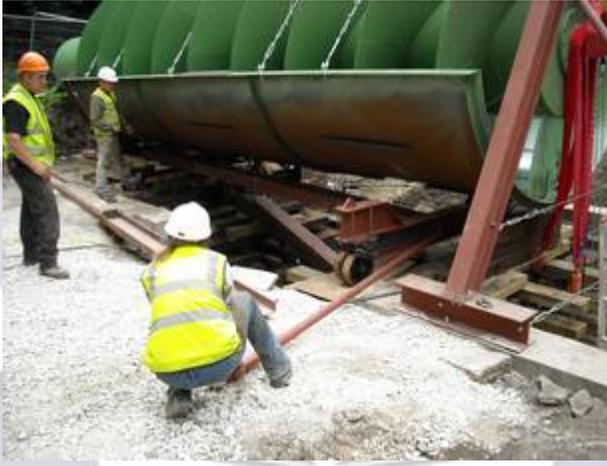
The turbine was crabbed out sideways, over the concrete channel and onto the temporary wooden structure. From here it was then suspended at one end to allow the removal of part of the trolley, and part of the wooden temporary structure

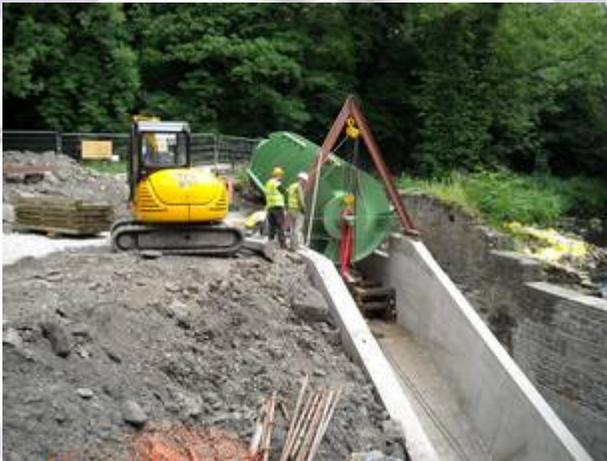
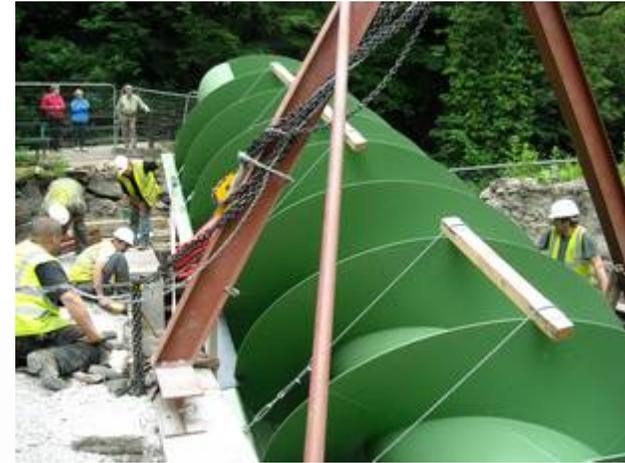
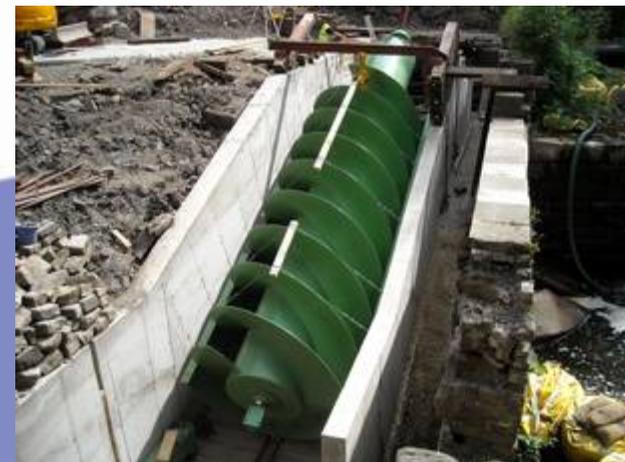
With the temporary wooden structure changed, the supported end was lowered until it was at 22 degrees, but at the top of the slope. From here electric winches under the wooden structure were gradually released, allowing the turbine to slide into position on a carefully located central rail running down the slope. This positioned the turbine in the approximately correct position, and allowed completion of the concrete works

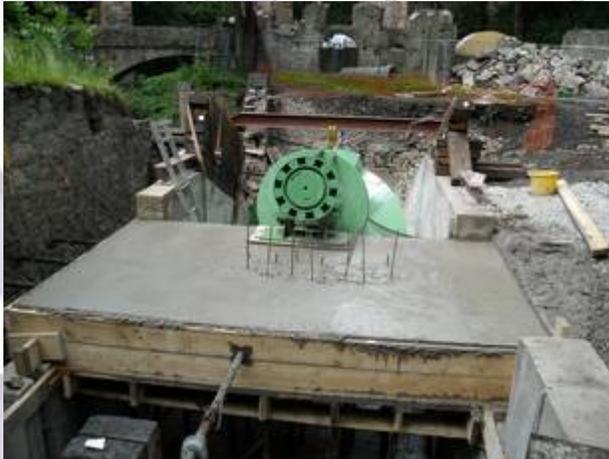
The top slab was then cast, and the turbine lowered onto it, after it had cured

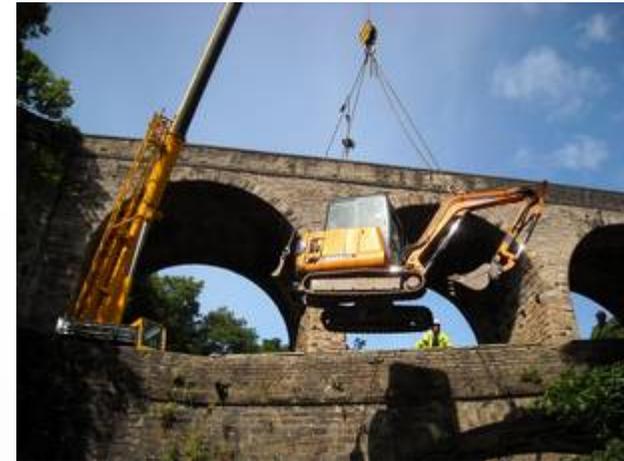
While the concrete was going off, other jobs commenced, including craning excavators into the river to excavate the tailrace and adapt the river bed

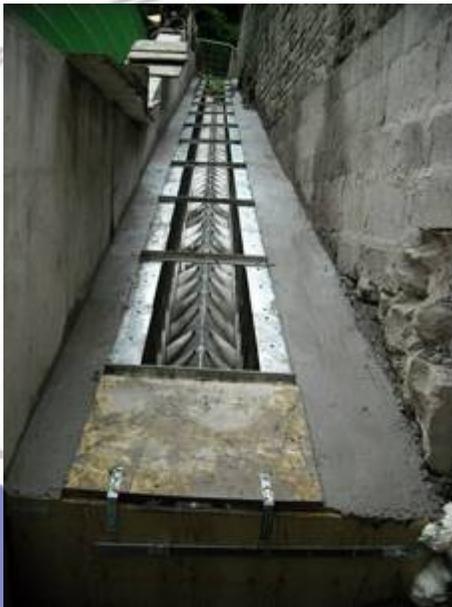
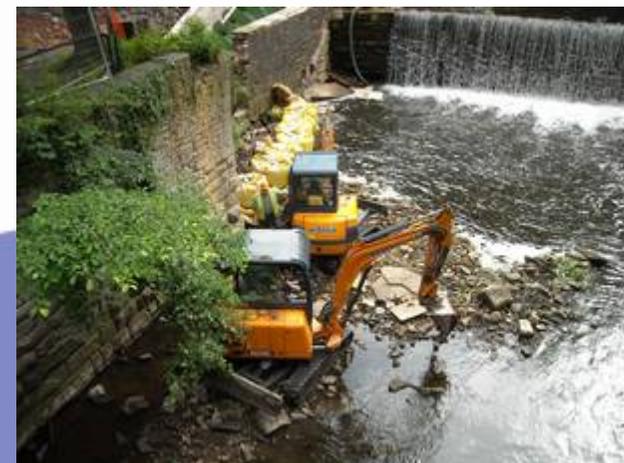
The fish pass was installed at this point, to allow migration of fish past the weir for the first time in over two centuries

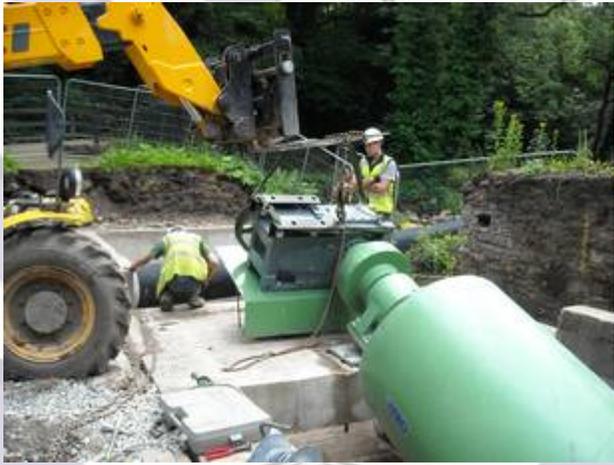
Transmission and generation equipment, as well as sluices and other ancillary equipment was then installed

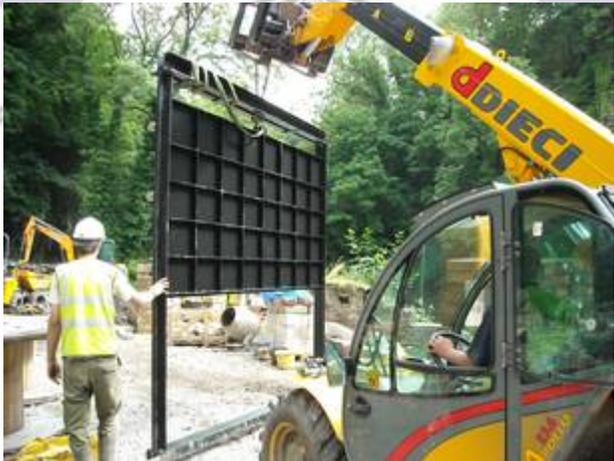
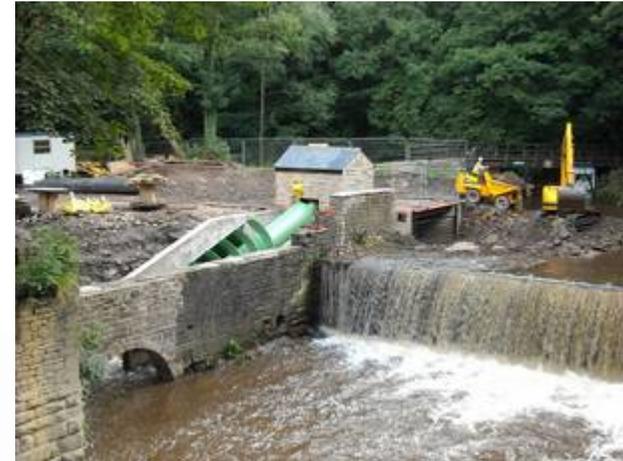
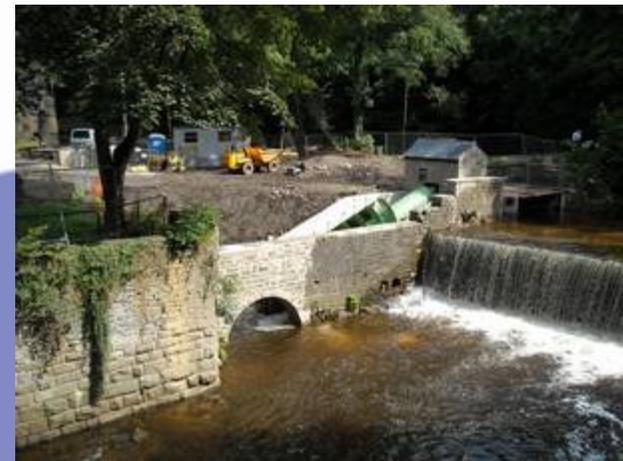
Finally the intake was excavated and the temporary storm outfall was removed, to leave the system looking much as the original artists impression had envisaged

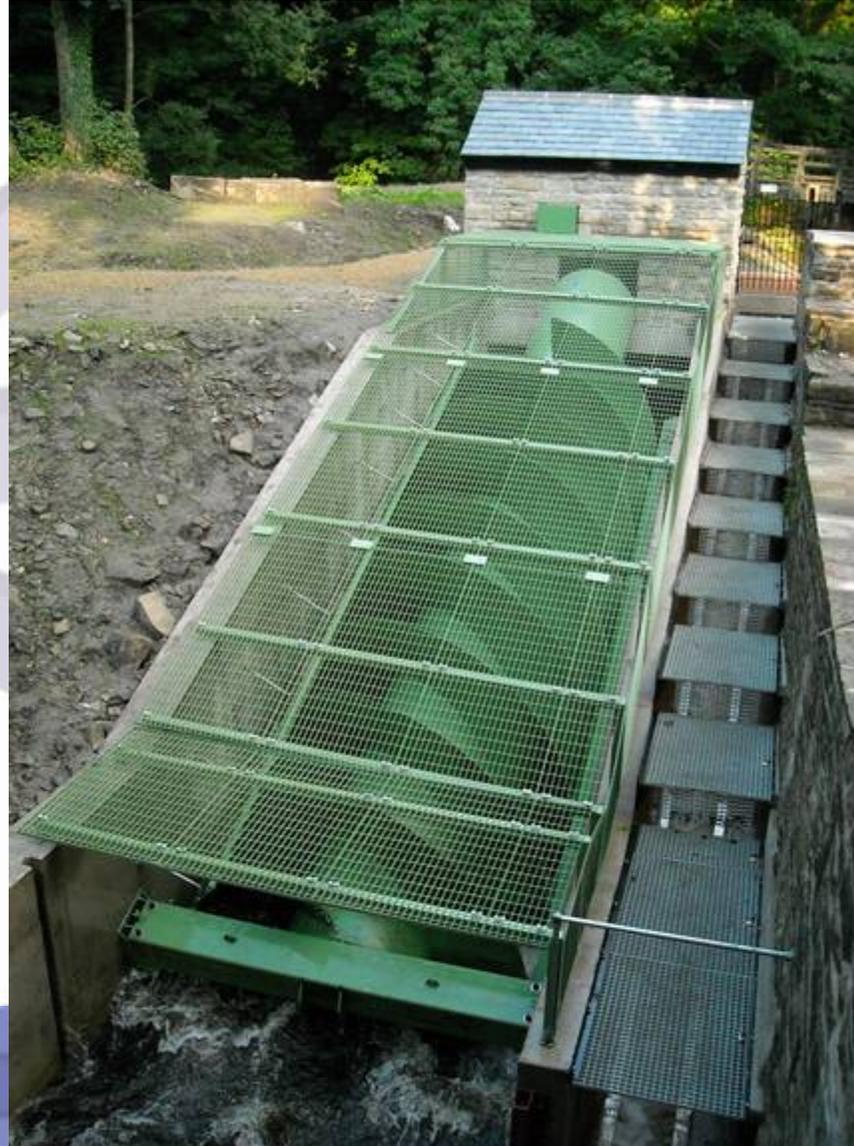
The final step was the installation of the guarding and fencing, as the system is located in a public park.
